NEW MEXICO ENVIRONMENT DEPARTMENT

Re: **Santa Monica Place Development LLC, Titan Development LLC/Santa Monica Estates; CGP;
SIC 1521; NPDES Compliance Evaluation Inspection; NPDES # NMR100105 and NMU001954;
December 20, 2017**

NPDES Construction General Permit Inspection Report – State of New Mexico

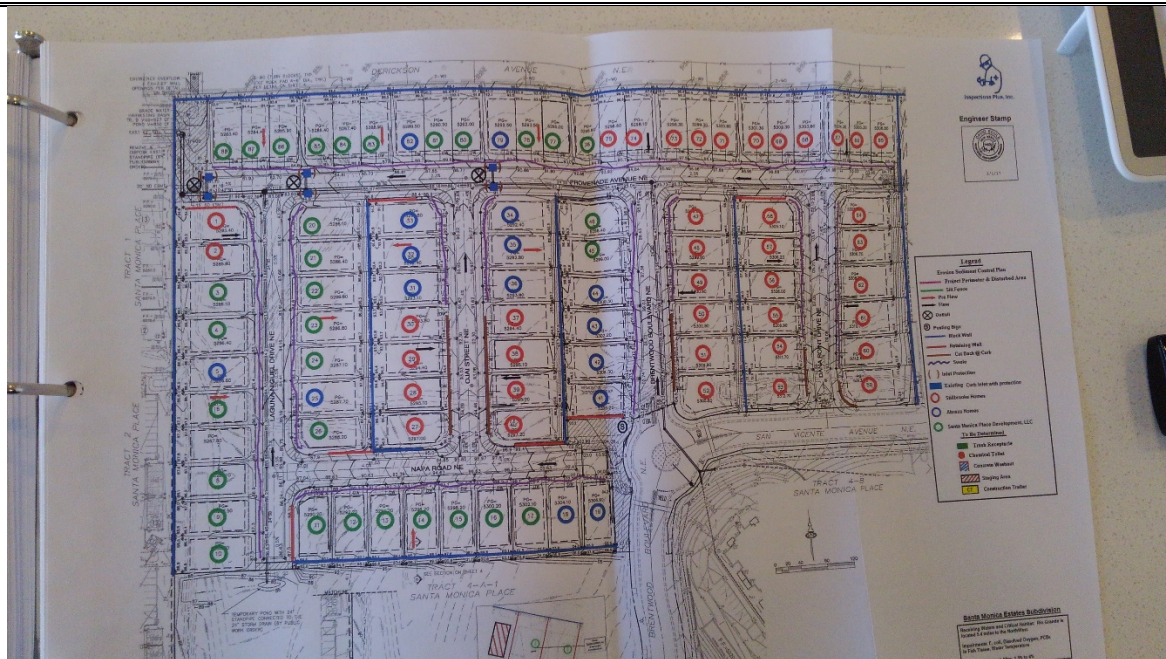
NMED/SWQB Official Photograph Log
Photo # 2

Photographer: Jennifer Foote	Date: 12/20/17	Time: 1:35 pm
City/County: Albuquerque, Bernalillo		State: New Mexico
Location: Santa Monica Estates		
Subject: Abrazo/TQM SWPPP site map showing parcel ownership for the three owners.

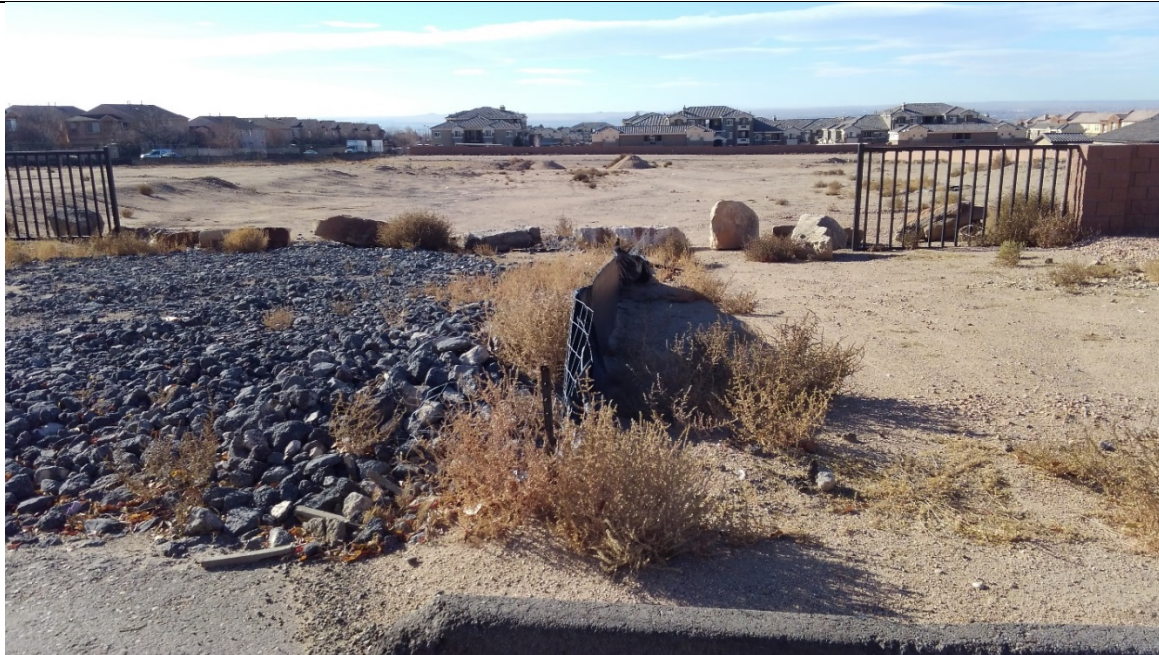
BMPs such as silt fence are not all maintained, the plan describes a low point behind the curb as the primary BMP (photos 3,4, 5, 6). There is no documentation of the date that temporary stabilization occurred or specifications that describe how long the soil tackifier is effective. Minor tracking was occurring at some of the homes (photo 5). Concrete and stucco washout was occurring around the site directly on the ground (photo 7).

NMED/SWQB Official Photograph Log Photo # 4		
Photographer: Jennifer Foote	Date: 12/20/17	Time: 2:10 pm
City/County: Albuquerque, Bernalillo		State: New Mexico
Location: Santa Monica Estates		
Subject: abandoned construction entrance, unstabilized area at undeveloped portion of site (Operator: Santa Monica Place Development)

- Part 2.1.4 Stormwater controls not maintained (Abrazo Homes, TQM, Santa Monica Place Development LLC, Stillbrook Homes)
- Part 2.2.14 No record of expected longevity and date of application of temporary stabilization of soil tackifier at inactive areas (Santa Monica Place Development)
- Part 2.3.4 Leak proof or lined washout not used. (Abrazo Homes, TQM, Santa Monica Place Development LLC, Stillbrook Homes)

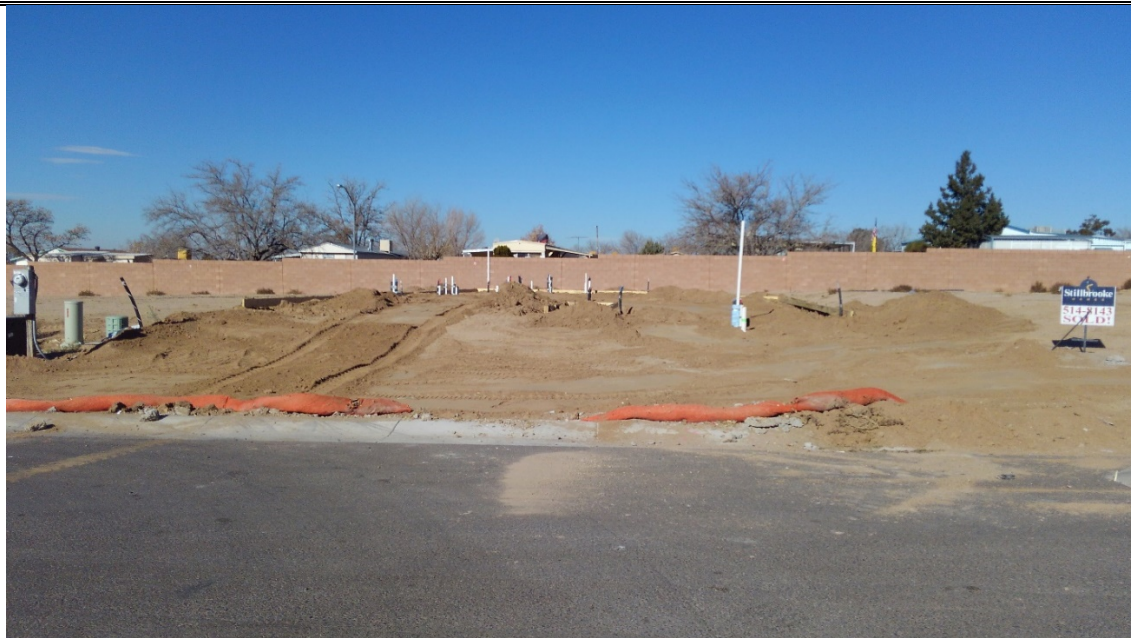
NMED/SWQB Official Photograph Log Photo # 5		
Photographer: Jennifer Foote	Date: 12/20/17	Time: 1:12 pm
City/County: Albuquerque, Bernalillo		State: New Mexico
Location: Santa Monica Estates		
Subject: tracking and BMPs in disrepair (Operator:Stillbrooke)
